# Energy Dissipation Problems Downstream of Jinnah Barrage

Z. A. Chaudhry<sup>1</sup>

<sup>1</sup> Civil Engineering Department, University of Engineering and Technology, Lahore, Pakistan (Hydraulic Specialist, Jinnah Barrage Modernization and Rehabilitation Project)

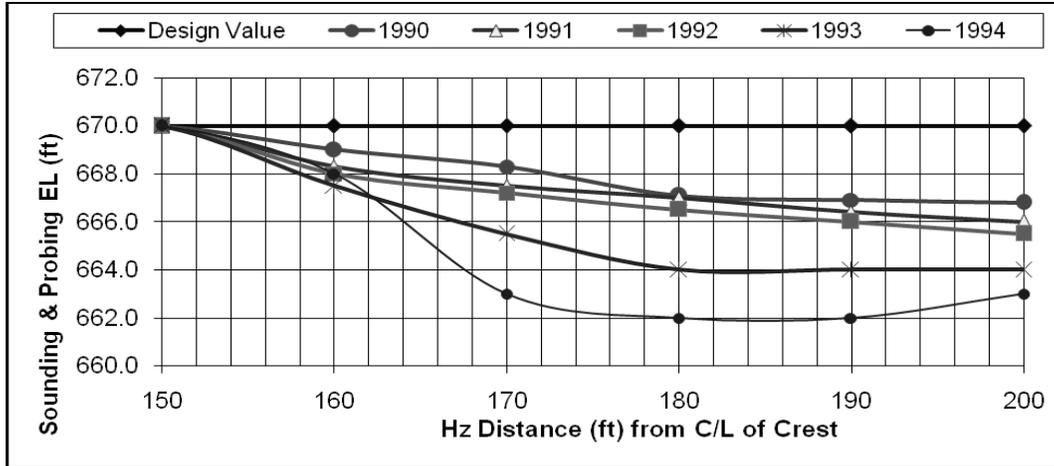
River sounding data for the Year 1990 to 1994 show that the super flood of Year 1992 aggravated the development of scour and consequently the stone apron became exposed and abnormally displaced (Figure 1). River sounding data to-date reveals that in the past the loose stone replenishment was not carried out considering its stability as per downstream pit conditions and water velocity.

Figure 1: sounding data analysis d/s of the Barrage for BAY NO. 26

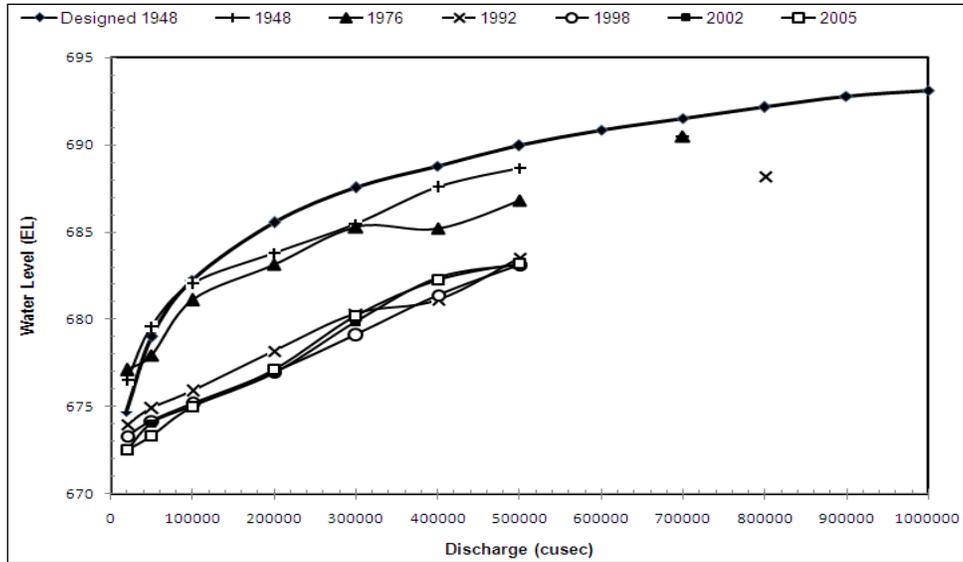
Water level variation, downstream of the Jinnah barrage for various discharges from the Year 1948 to 2007 was analyzed. The data is plotted in pre-Tarbela and post-Tarbela context. It was noted that the rate of drop of water level slowed down by the Year 1976 and got accelerated after the Year 1976, when the Tarbela dam started operating. However, for about last fifteen years, water levels became stable and no further retrogression occurred as depicted in Table 1 and Figure 2.

Figure 2: Water level variation downstream of the Jinnah barrage.

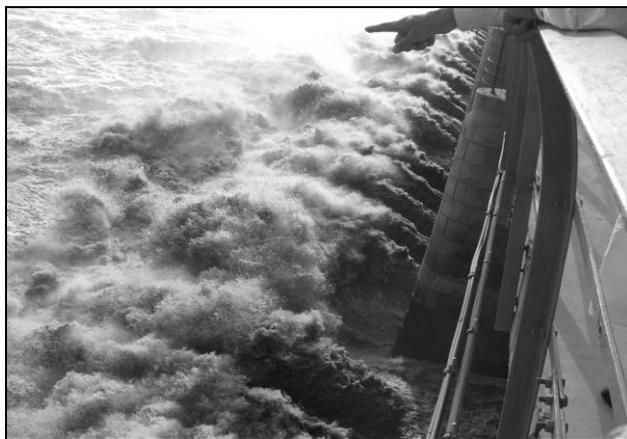
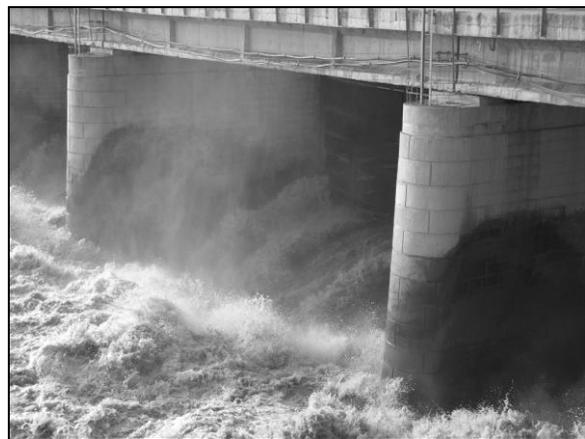
on the horizontal floor of the weir section. Impact blocks take the force of water directly and help to stabilize and terminate the jump over the paved floor (Figure 3 & 4). The striking water with high velocity causes abrasion/damage to the blocks and surrounding concrete floor. At undersluices the jump develops on the glacis and no damage has been reported to the impact blocks and concrete floor.

Figure 3: Hydraulic Jump formations at weir and undersluices sections for the discharge of 240,000 Cusecs. (Noted on 15-06-2007)

Performance of energy dissipation mechanism at the Jinnah barrage was further investigated by taking field observations at the barrage. On 15<sup>th</sup> June 2007 the discharge at the barrage was about 240,000 cusec (6795 cumec). At the weir section the jump swept, however impact and friction blocks helped in developing and terminating the jump over the paved floor (Figure 3). Energy dissipation in the jump

was satisfactory as the velocity downstream of the jump remained less than 9 ft/sec (Table 1). At the undersluices sections the hydraulic jump was developed over the glacis and the energy dissipation was good (Figure 3 & Table 1). A second technical visit was conducted from 7<sup>th</sup> to 9<sup>th</sup> November, 2007. The discharge in the river was about 100000 cusec (2831 cumec). Hydraulic jump characteristics at undersluices and weir sections were almost similar as were observed for the discharge of 240000 cusec, Figure 4.

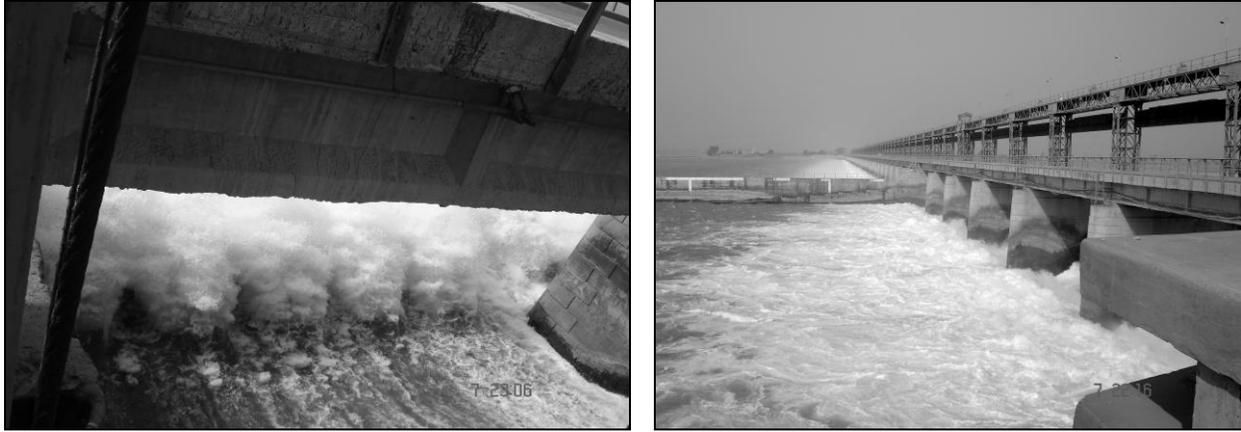
**Figure 4:** Hydraulic jump formations at weir and undersluices sections for the discharge of 99,000 cusecs. (Noted on 07-11-2007)

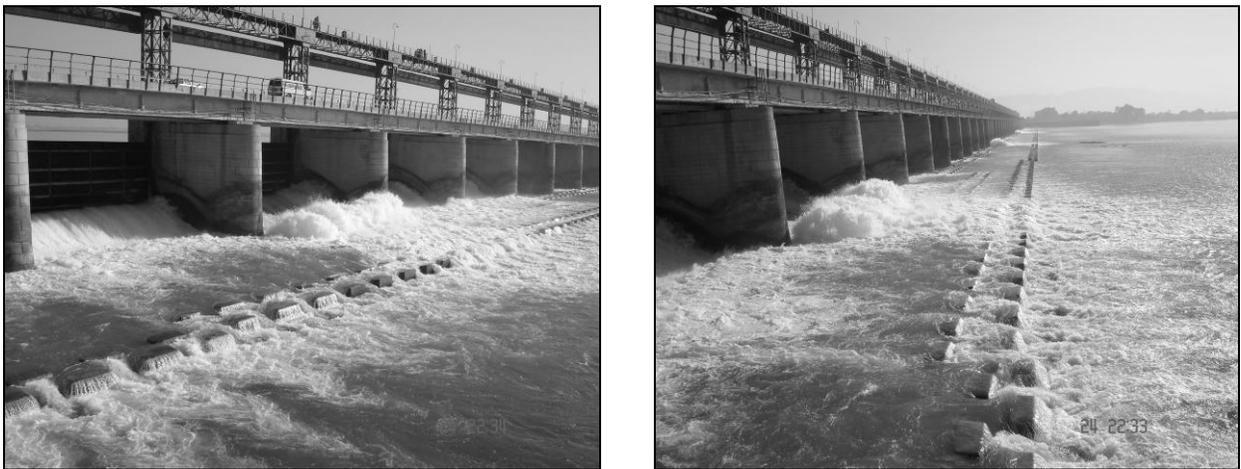
Jinnah barrage energy dissipation mechanism can be approximated as USBR type IV stilling basin, in which instead of dentated sill, two rows of concrete blocks are provided. These blocks control water depth at low discharge as shown in Figure 5, dissipate some of the energy and allow passing of gravel and pebbles. This arrangement is quite efficient for the gated control low flows and is not very sensitive to downstream water depth [9].

**Figure 5:** Hydraulic jump formations at the barrage for the discharge of 27,000 cusecs. (Noted on 24-12-2007)

Third technical visit was conducted on 24<sup>th</sup> & 25<sup>th</sup> December 2007 and river flows were 27000 cusec (764.4 cumec) and 12,700 cusec (360 cumec), respectively. At these discharges the friction blocks retain water and develop higher depths along with dissipation of some of the kinetic energy (Figure 5). Finally, another site visit was carried from 25<sup>th</sup> to 28<sup>th</sup> January, 2008. The gates at the undersluices were completely open and the flow was mainly through undersluices and silt excluder. The hydraulic jump was formed over the glacis of the undersluices.

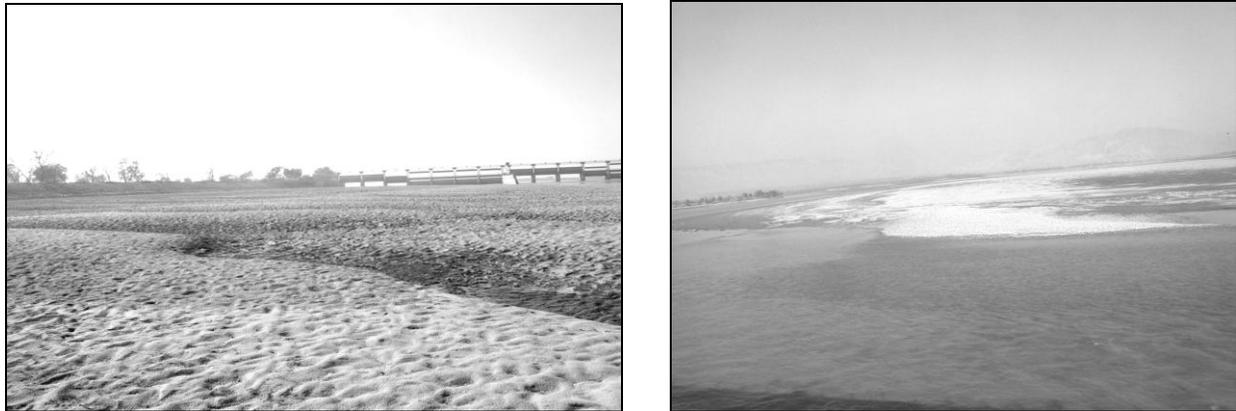
**Figure 6:** Sand and shingle deposited upstream of the barrage. (Noted on 26-01-2007)

On upstream, the right side creeks were active and there was no flow in left side creek. A parallel flow on upstream was noted from right to the left undersluices. Just upstream of left undersluices, a huge quantity of sand was deposited (Figure 6), indicating that the upstream end of left guidebank is not streamlined with the incoming flow. Shingle deposits were noted upstream of the weir bays 23, 24 and 25.
