Deterioration of Śarda Temple, Neelum Valley, Pakistan: General Perceptions vs New Findings

JUNAID AHMAD, ABDUL SAMAD AND ANAS MAHMUD ARIF

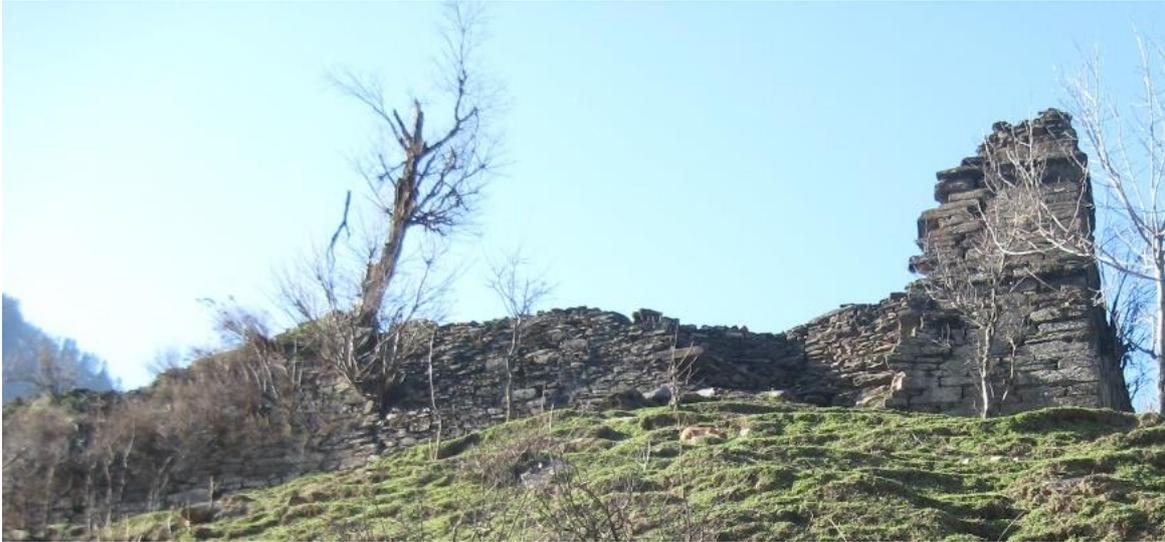
Figure 1. Southern side of the temple lapsed due to the weakening of foundations by floods

Seeing the site, existing by the sides of a streams can give us a clue that it would have been the victim of such flood that washed the bases of the structure to some extent. Even if it could not have reached it directly, the vibration caused by the flow of huge debris can also work destructively. There are signs of such passing of flood water near to the site. This possibly triggered the southern wall to lapse down (Figure 1).

To the southern side it can be assumed that there was extra piece of land which is now washed by the floods of the stream. However, with the existence of massive ramp formed by stair case, we can exclude the possibility of same destruction to the west.

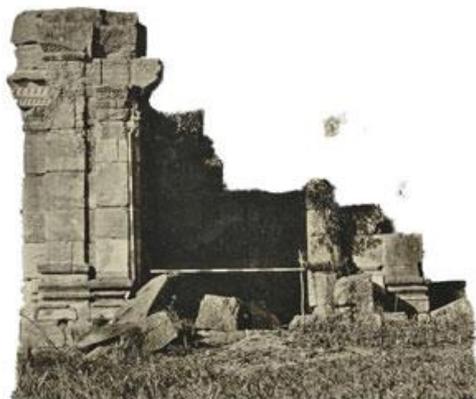
John Burke 1868 Sugandheswara. reproduced in Cole(1869) (British Library Photo 981/1(36))

Sugandhesa from south 2011 with missing and displaced blocks

John Burke from East 1869

Sugandhesa from East 2011

Figure 3. Views of *Sugandhesa*: top pair from the south in 1868 (Cole 1869, left) and 2011 (right), and lower pair from the east, showing damage sustained in the 1885 earthquake, and evidence of toppled blocks that we interpret to have fallen in previous earthquakes. Arrows highlight lateral block motions typical of earthquake jostling. The gradation of the poles visible in the left hand figures are in feet (After Bilaham et al 2013: Fig 13).

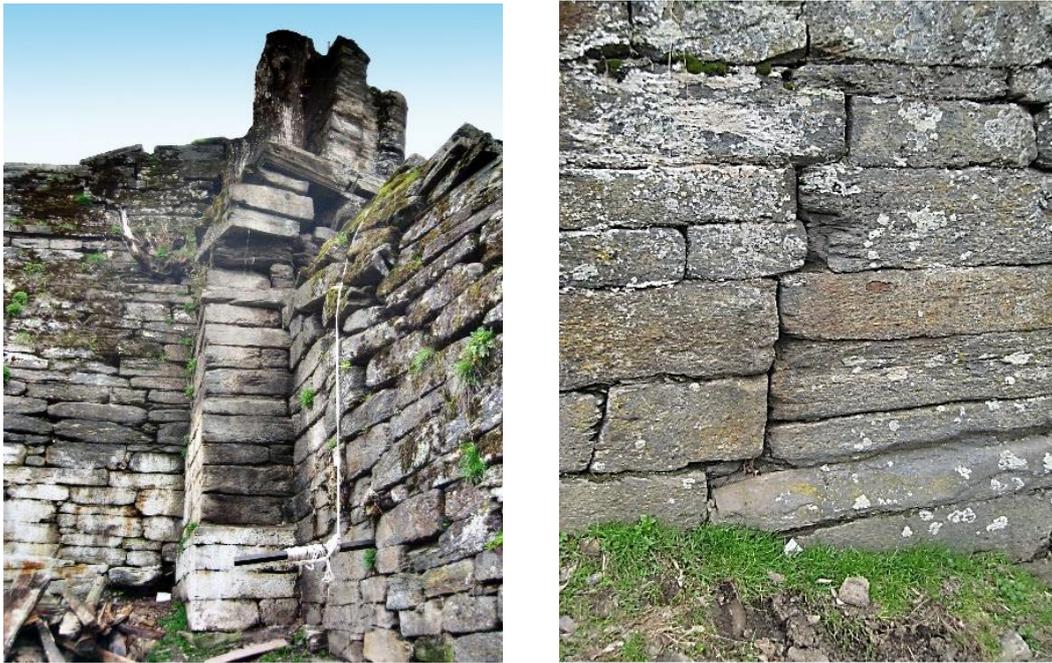
Figure 4. Earthquake jostling in *Sarda* Complex a. joint of stair case with the main court b. outside view of the base of the northern wall

This jostling in the *Śarda* Site (Figure 4-a) is obvious that it is a flood generated thrust that tended the site to very slightly tilt toward the south. On the contrary, the northern side

(Figure 4-b), resting relatively on a solid ground, seems to have struck by the earthquake. Earthquake jostling can also be observed even in the foundation of the northern side wall. The map of the observable forces on the structure (Figure 5) is also consistent with the same.

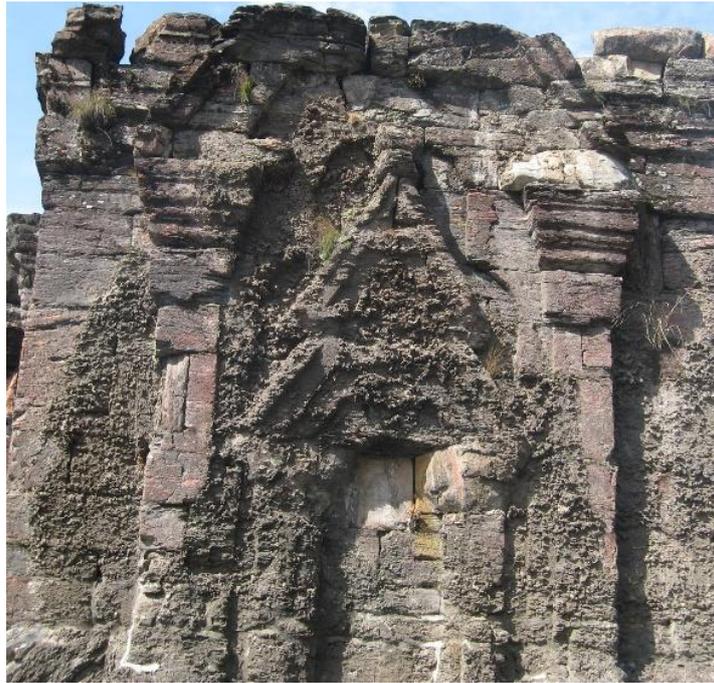
Figure 6. Deteriorations caused by biological growth on the surface

The site is surrounded with a commanding naturally active environment. Humidity, temperature, rains, freezing, etc. as a whole are other agents of decay. Mosses are grown on the site and destroyed the site in a very drastic manner (Figure 6).

To the southern side of the temple main shrine, a crusty layer of plastering material (possibly stucco) is apparent which demonstrates the rate of biological decay.
