# Conservation of Historic Monuments in Lahore: Lessons from Successes and Failures

Abdul Rehman<sup>1</sup>

<sup>1</sup> Department of Architecture, University of Engineering & Technology, Lahore

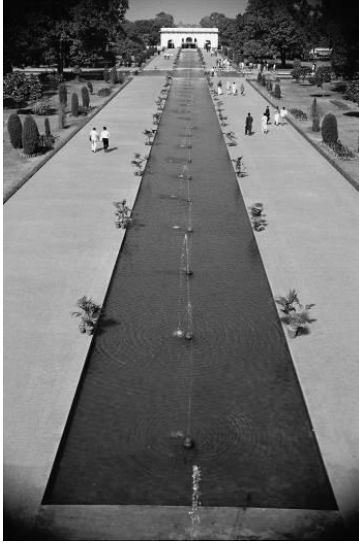
**Figure 2:** Shalamar garden upper terrace

The second degree is moderate authenticity. Restoration and rehabilitation fall in this category. Although in restoration (Figures 2 & 3) authentic information is required to undertake any job but sometime historical materials and level of craftsmanship are not available to undertake such jobs. In adaptive reuse sometimes changes are required to be carried out which may change its original appearance. But in these actions it is important to undertake decisions which safeguard originality and authenticity.

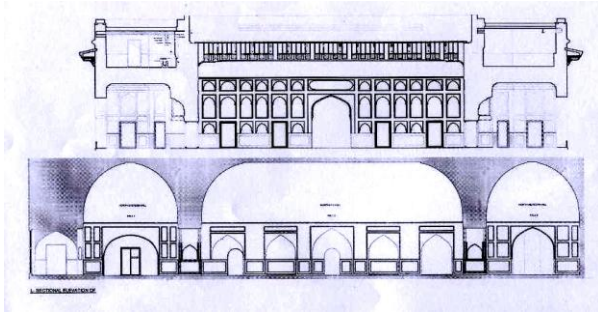
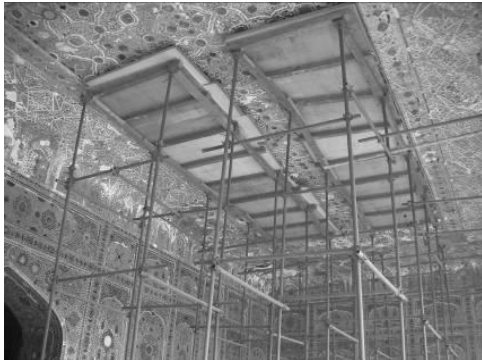
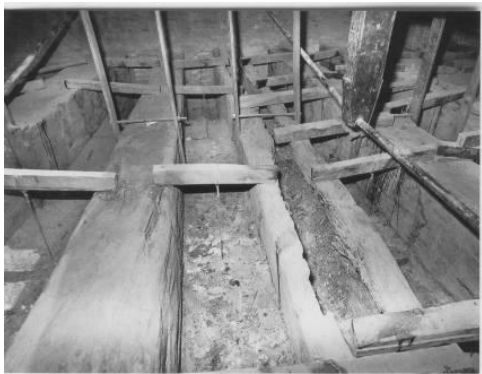
**Figures 7, 8 & 9:** Section of Shish Mahal

The second case study being described here is that of Shah Burj (commonly known as Shish Mahal) located in the north western corner of Lahore Fort. This project was initiated by fourth Mughal emperor Jahangir and completed during the reign of his son Shah Jahan in 1631-32. The most important feature of this monument is the mirror mosaic work (*ayina kari*) applied on the walls and ceilings of all interior spaces [4]. These convex glasses were fixed in *guch* (gypsum) plaster. The ceiling comprised of a layer of gypsum plaster applied on wooden lattice structure supported by wooden beams. The seepage of water from the roof and termite attack, the beams got deteriorated; therefore, the ceiling started losing its connection with the lattice structure. There was enormous challenge before the conservators. The Department of Archaeology undertook a conservation and restoration project with the financial assistance of NORAD and UNESCO. After the expert advice it was decided that a new grid of wooden beams may be constructed to transfer the load of ceiling to new structural system. The original ceiling of *guch* left its contact with the wooden lattice structure 1½ inch apart on each side. The lattice structure was later repaired at places with bamboo strips. It was decided to lay stainless steel wire mesh over the existing ceiling and then tie them up with wooden beams. Once this is done then a layer of *guch* mortar was spread over the mesh so that old and new layers become monolithic. The entire load was transferred to wooden beams placed above the wooden grid (Figures 7, 8 & 9).

It may be mentioned here that during the conservation operation, sheets of polystyrene were placed under the ceiling to support the structure which was removed after the completion of the task. It was found that this experiment was partially successful. At some places the ceiling got fixed while at other places it fell down. Looking into the conservation process, it was found that two factors were responsible for the partial failure of this process. Firstly, there was not adequate pressure from the base and secondly the upper surface of the *guch* plaster was not prepared adequately to make proper adhesion of new and old plaster. As a result the two surfaces could not become monolithic (Figure 10). There was not adequate supervision during the execution of work. A high level advisory committee was formed by the UNESCO but none of them had any practical conservation experience. However Pakistani specialists who had sufficient experience were not considered in the conservation work.
